A FRAMEWORK FOR THE EVALUATION OF THE STRUCTURAL SAFETY OF EXISTING CONCRETE GRAVITY DAMS

CLYDE LLELAND DANKERS

DEPARTMENT OF CIVIL ENGINEERING

UNIVERSITY OF CAPE TOWN

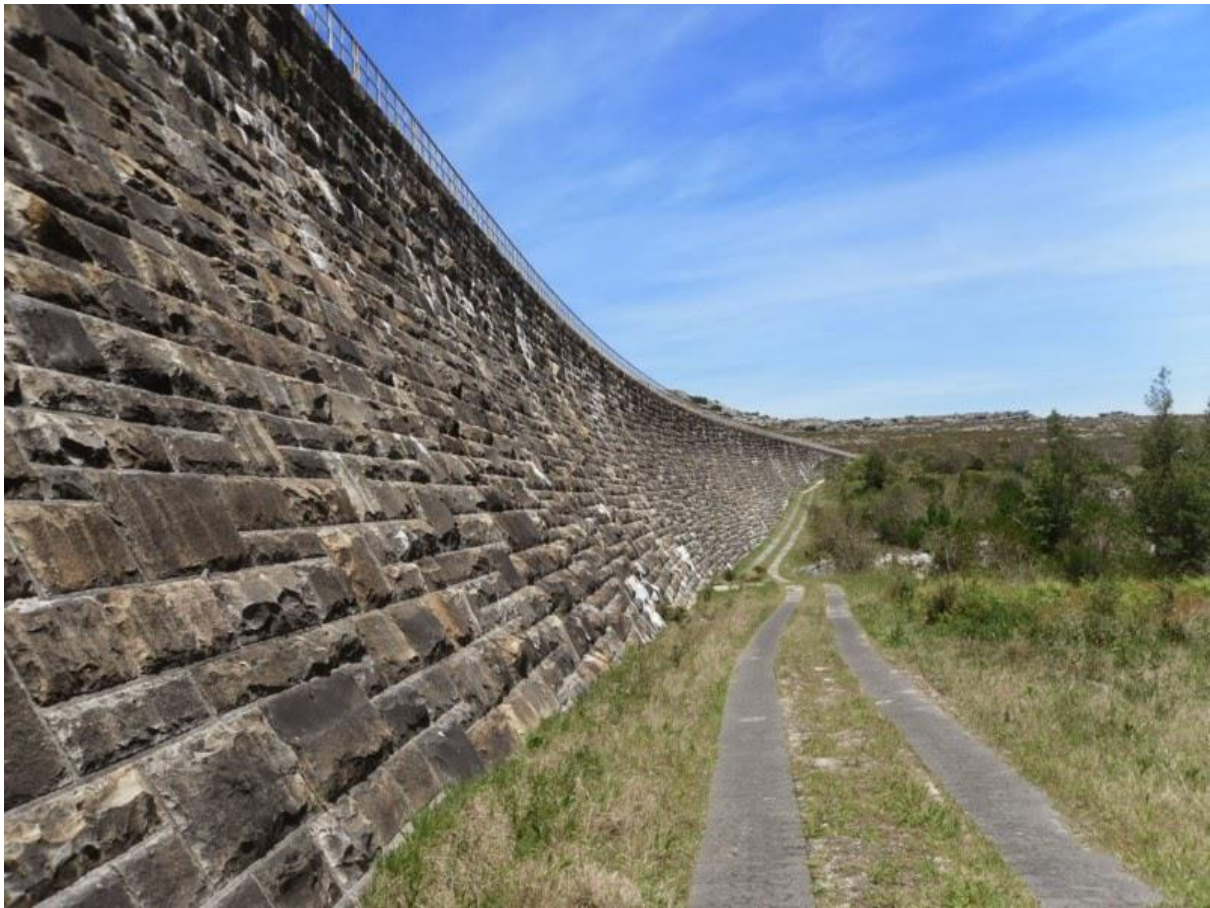
Masonry gravity dams are constructed using brick, stone, rock or concrete blocks sometimes joined with mortar. The Hely-Hutchinson dam (completed in 1904) and Woodhead (completed in 1897) dam on Table Mountain in Cape Town, South Africa are typical examples of masonry gravity dams. Figure 4 displays a downstream view of the Hely-Hutchinson dam.

Figure 4: Hely-Hutchinson dam constructed (completed) in 1904 is a typical example of a typical masonry gravity dam (Crawford, 2013)

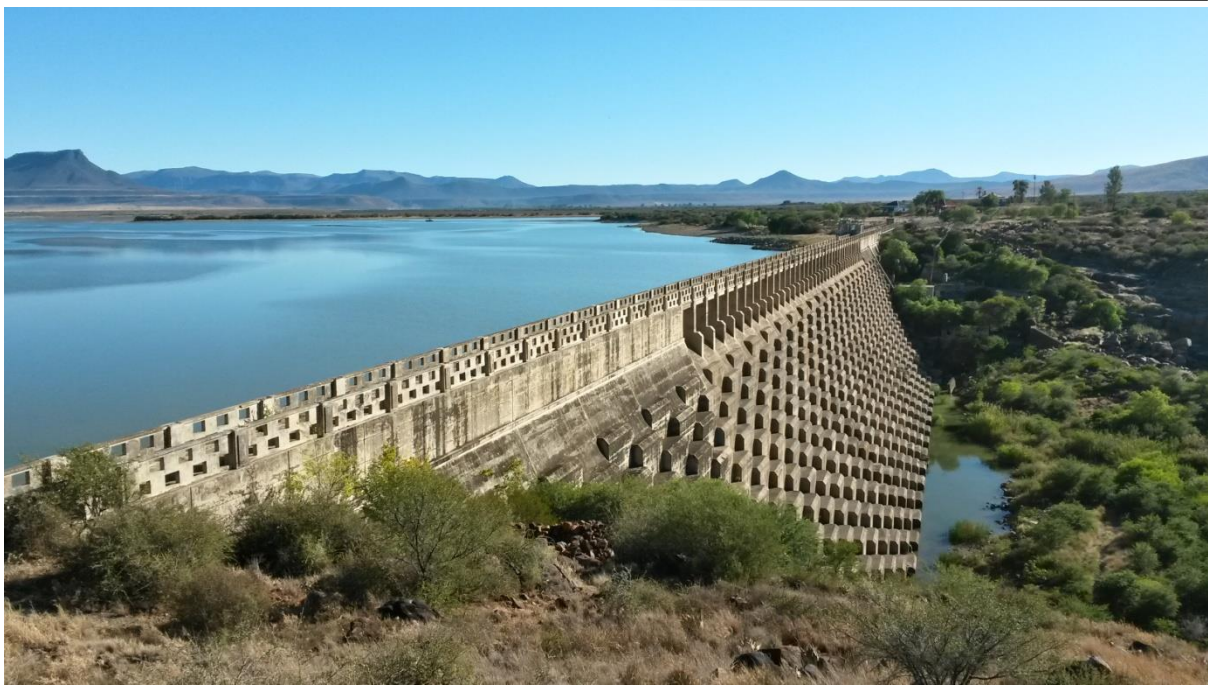
Figure 5: Nqweba dam, constructed (completed) in 1920 is a typical example of a mass concrete gravity dam. The stepped downstream face is quite a unique finish.

As the name suggests, conventional mass concrete gravity dams are constructed using large volumes of concrete. Due to the expansion and shrinkage caused by the heat generated during the cement hydration process of conventional concrete, the size and rate of placement is limited and necessitates building in monoliths to meet crack control requirements (USACE, 1995:2-1). As a result, these dams are vertically constructed in individually stable large blocks (or monoliths), by placing large quantities of concrete (typically in 1.5 to 3 m lifts) into pre-set forms and consolidating the concrete by means of pneumatic vibration. To meet crack control requirements, it is also vital that the concrete mixture is of the correct proportions and that environmental influences (like temperature and moisture) are controlled. An example of a mass concrete dam is presented in Figure 5.

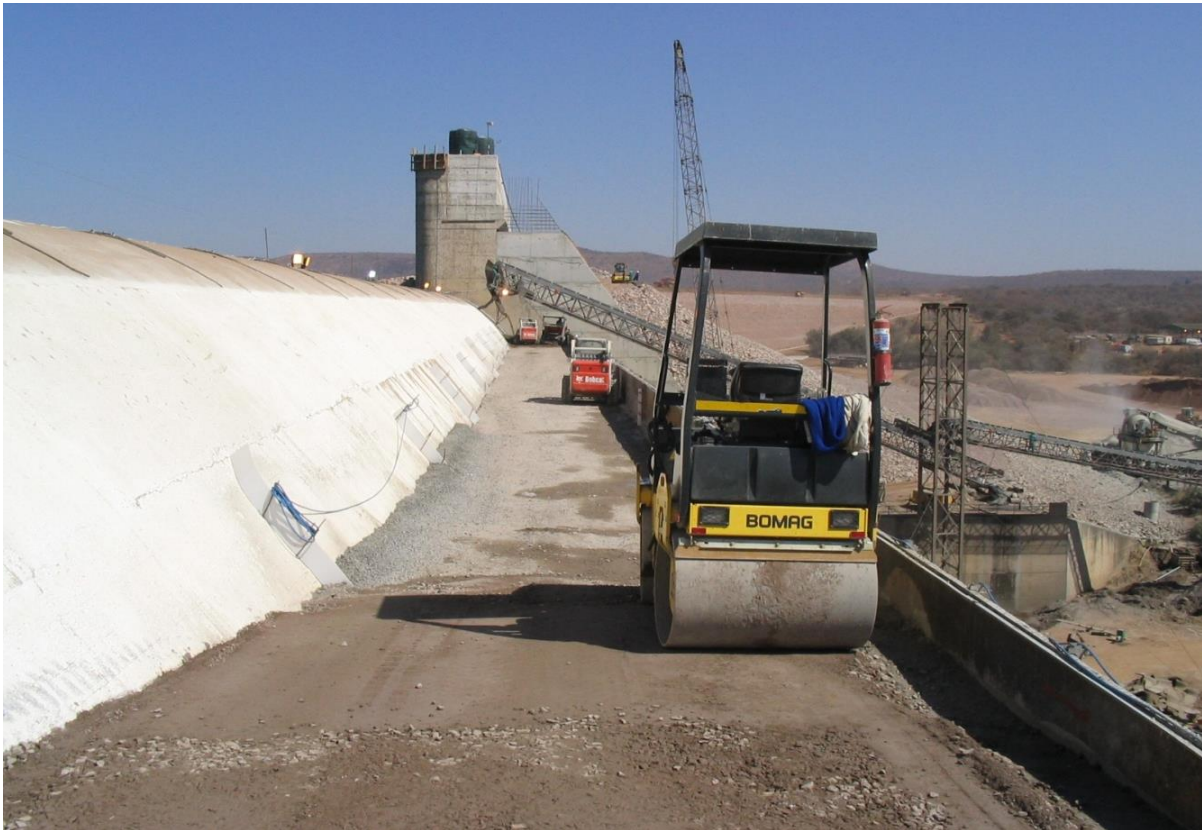
Figure 6: Example of an RCC dam: Flag Boshielo dam (originally constructed in 1987 and raised from 2004 to 2006).

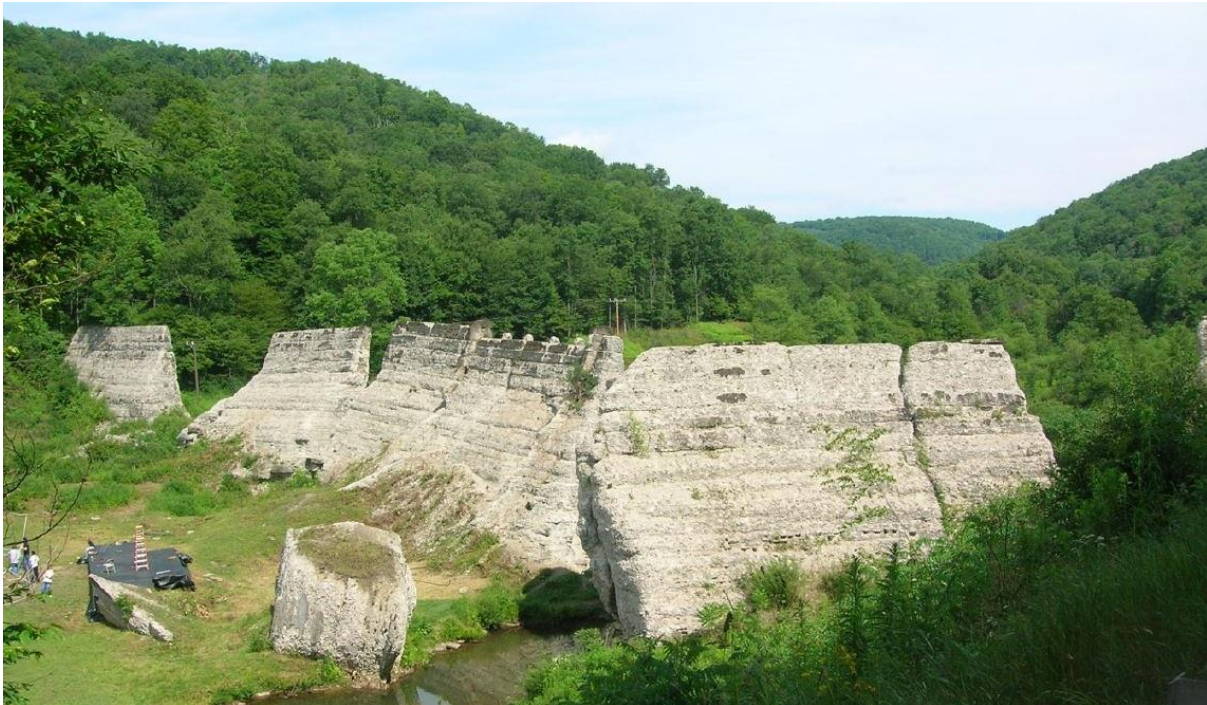
Figure 11: The remains of Austin Dam (Rose, 2013a)

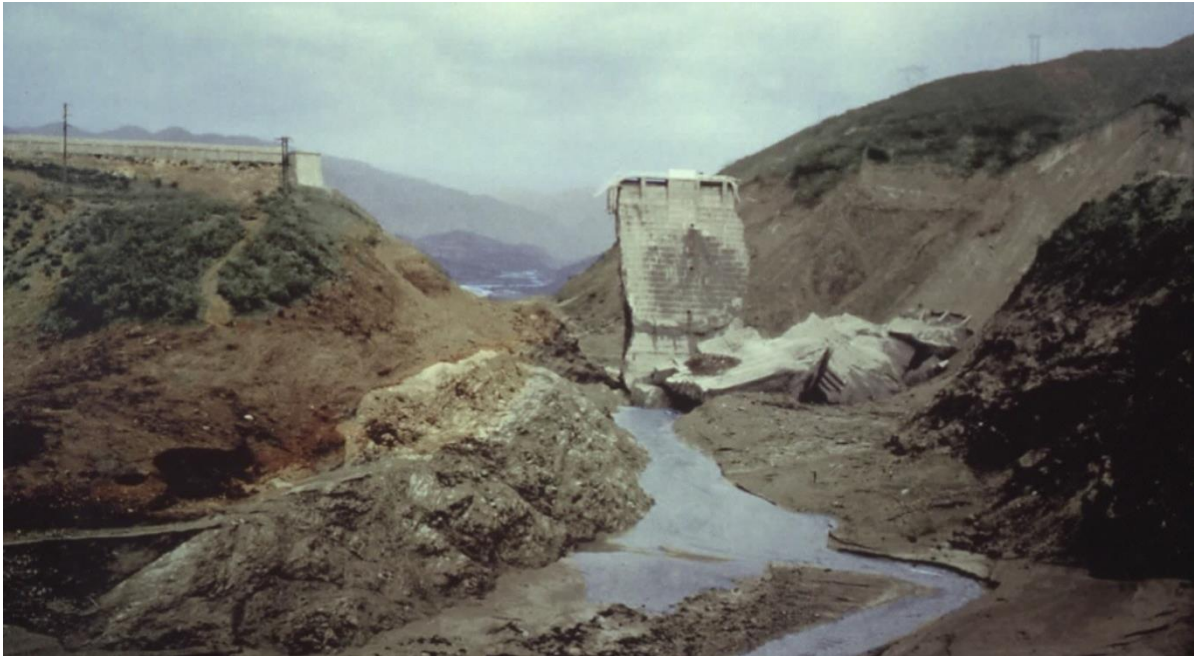
Figure 13: The remnants of St. Francis Dam - only the sloping abutments failed. Photo from the C.H. Lee Collection, U.C Water Resources Centre Archives, Colourized by Pony Horton (Rogers, 2006:34).

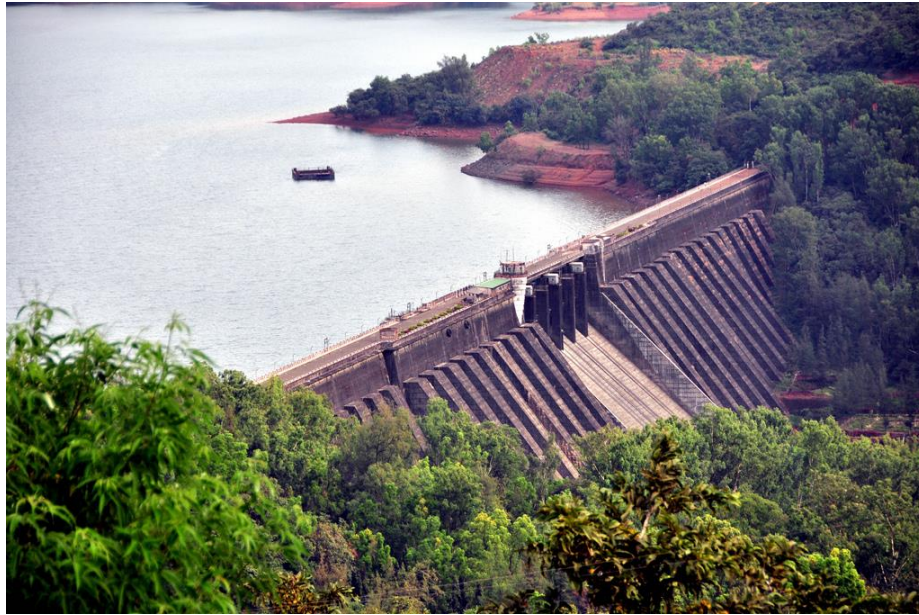
Figure 14: Koyna dam (Parikh, 2011)

The dam survived the earthquake without major loss of water (USBR, 1998:40). However, the dam suffered significantly deep horizontal cracks on both the upstream and downstream sides in areas where stress concentrations were expected to develop (i.e. in the upper part of the wall, approximately at the level of the change in downstream slope).

The cracks were grouted, and the dam was strengthened by vertically pre-stressed cables in the upper part of the non-overflow sections and adding concrete buttresses to the downstream face. The spillway section was also later in 2006. The dam still stands today and is expected to be able to withstand future earthquakes of higher magnitudes than that of the Koyna Earthquake.

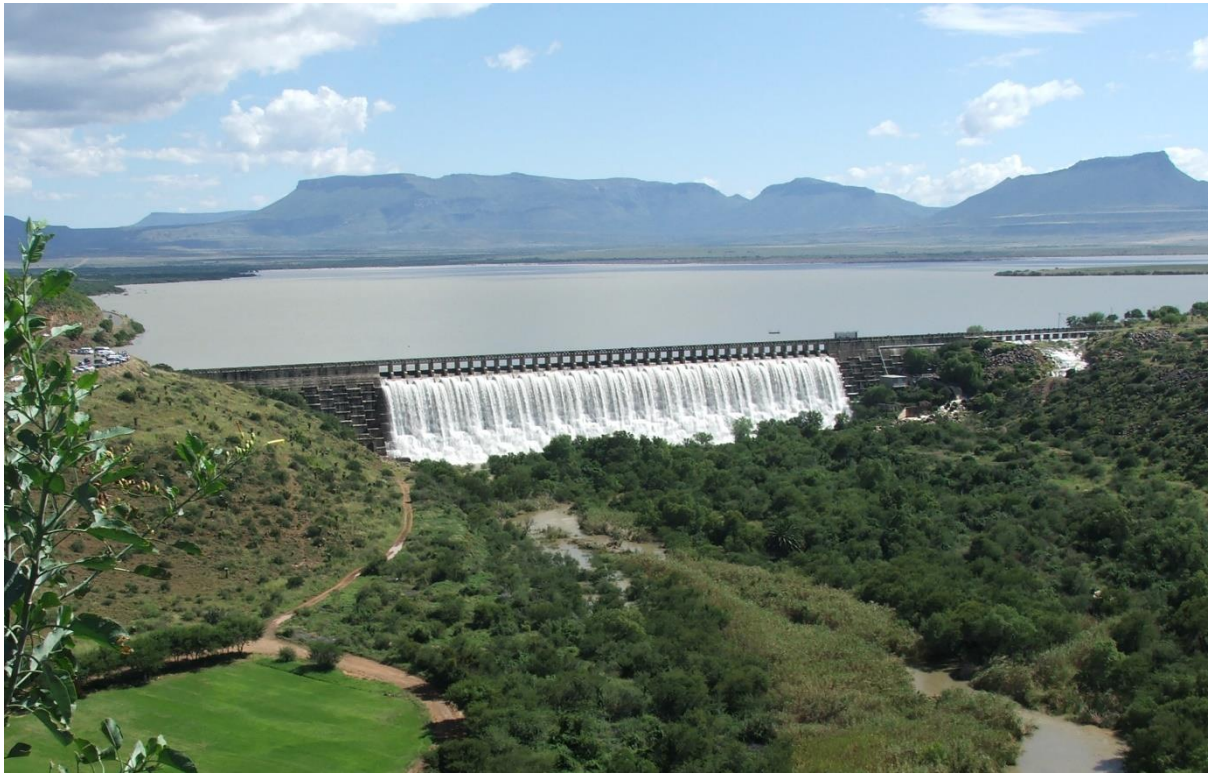
Nqweba dam was designed and built by the Irrigation Department which is known today as the Department of Water and Sanitation. Construction of the dam began in 1921 and was concluded in 1925. The dam wall is a concrete gravity structure, with a unique stepped downstream face finish. Downstream views of the dam are presented in Figure 5 (in Section 2.2.2) and Figure 18 (during overspilling). The steps dissipate the energy of the water over spilling the structure to reduce the impact of the water and erosion on the toe and foundation immediately downstream of the dam.

Figure 18 : Downstream view of Nqweba dam during overspilling, presumably in 2008 (Dam 2008, n.d)

The wall has a maximum height of approximately 46 m at its deepest section. And it has a crest length and width of 381 m and 3 m, respectively. Over the years, the dam has lost a significant portion (approximately 43%) of its capacity as a result of siltation. It currently mainly provides water to the Camdeboo Local Municipality, for domestic purposes. The dam is classified as being a large category III dam with a high hazard potential (see Appendix A for more information about dam classifications). The table below summarises some general information of Nqweba Dam.

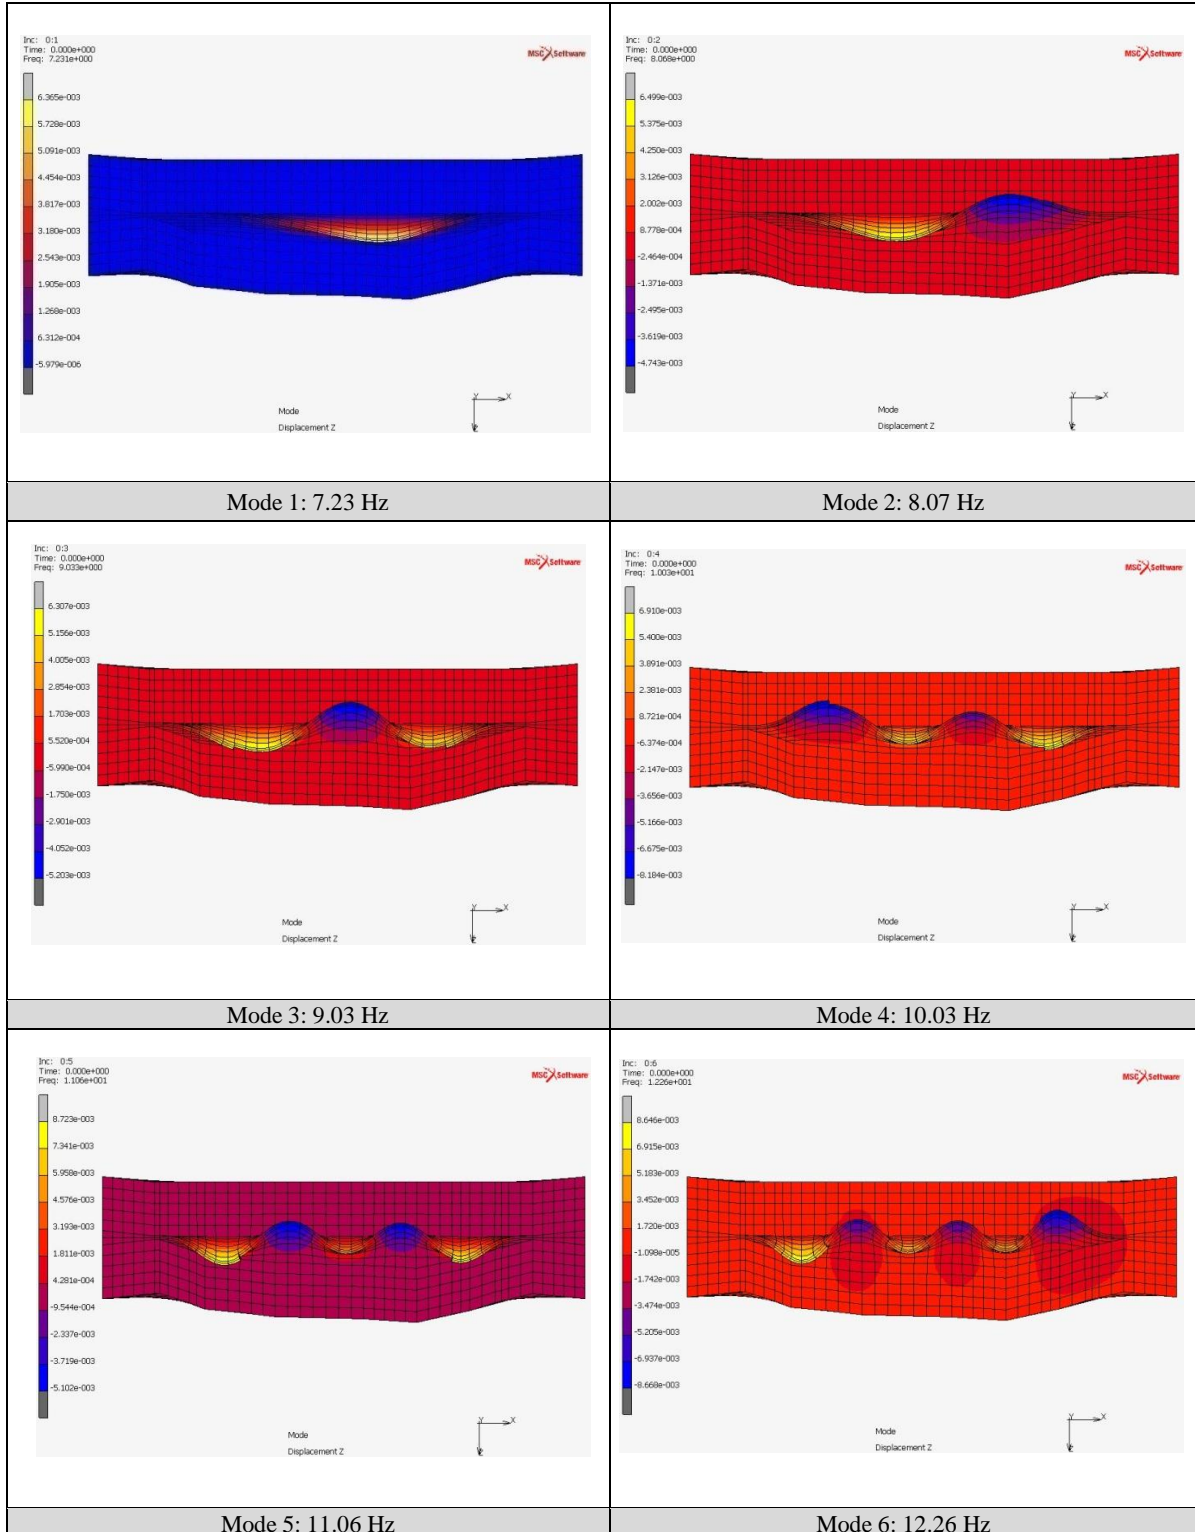
3D Mode Shapes and Natural Frequencies
